MOUNTAIN POND DAM

NH 00464

PHASE I INSPECTION REPORT NATIONAL DAM INSPECTION PROGRAM

AUGUST 1978

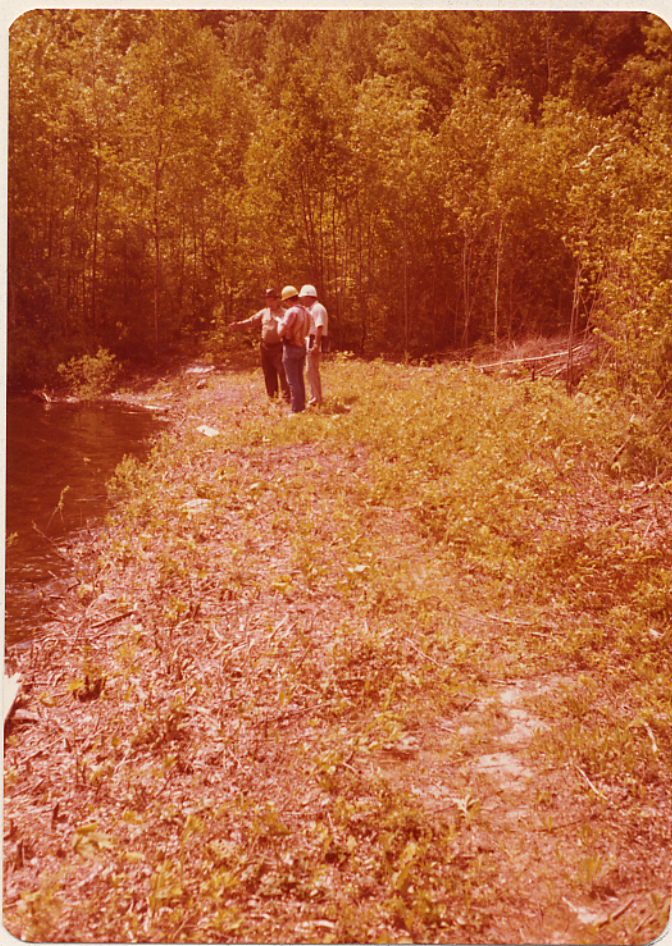
Overview from right abutment

The dam (shown in the Figures of Appendix B) is in FAIR condition with no evidence of distress. However, the downstream slope was overgrown with stands of saplings, heavy brush and some birch trees up to 12 feet high (see Overview photos).

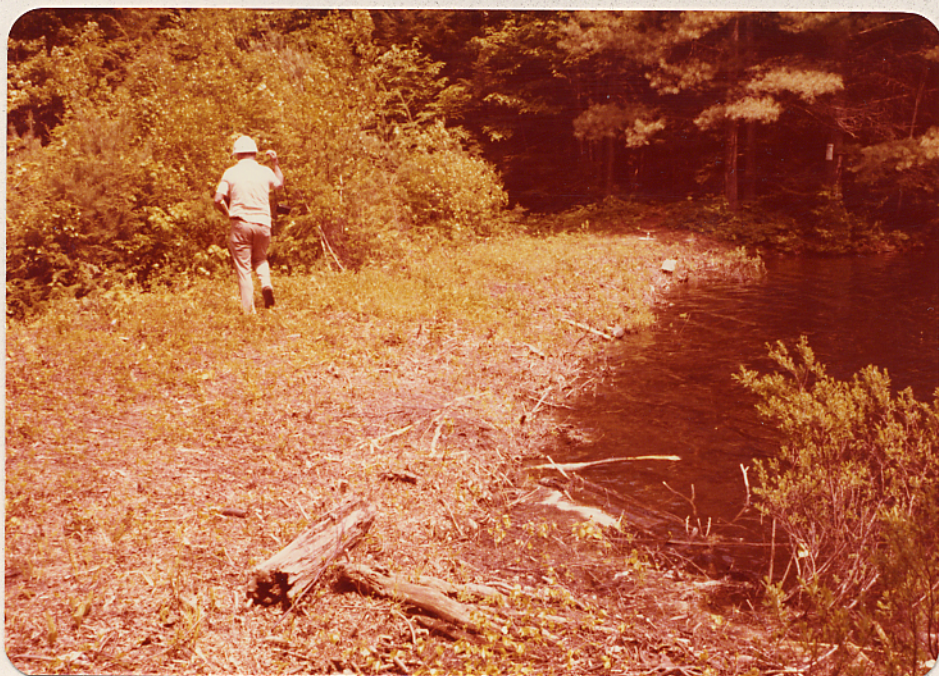
Overview from left abutment

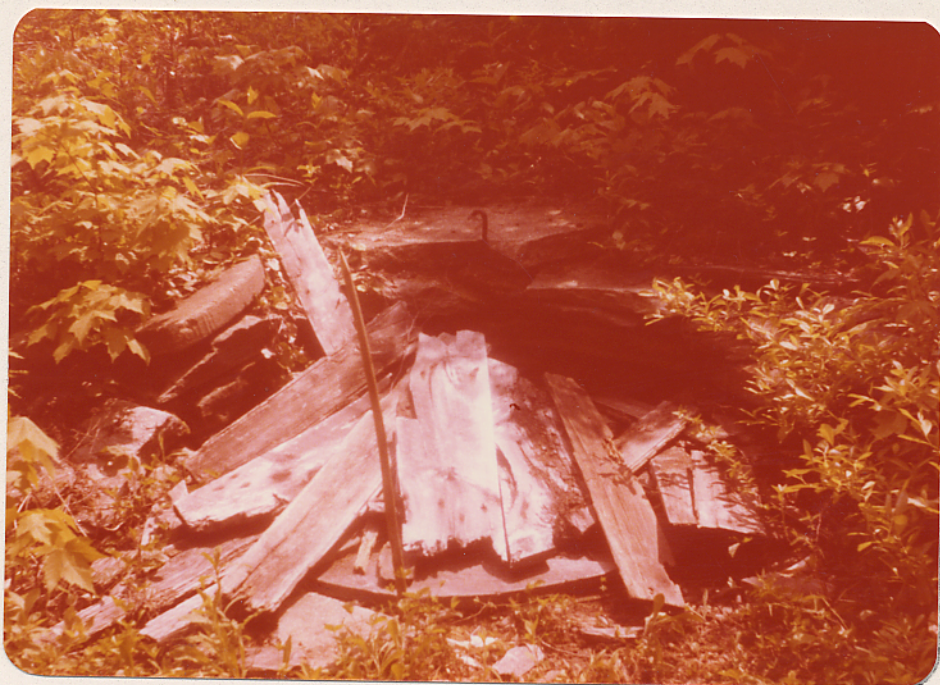
Discharge works are generally in FAIR condition, with some exceptions. An open manhole for the gate valve is covered with random deteriorated boards, apparently the remains of a former wooden cover (Photo 1). The gate stem handle is kept some 10 feet from the manhole in the undergrowth, whence it is retrieved when the gate is to be operated. The gate operates without difficulty, but requires care and experience to set for the constant flow required to match the Town's water demand.

The only operating facility is the gate valve itself which is in satisfactory condition. However, the manhole cover is in serious disrepair and there is no permanent on-site location for the gate valve handle.

1. Manhole with cover containing gate valve on downstream slope

The debilitated gate manhole cover should be replaced, and a permanent protected housing provided for the gate stem.

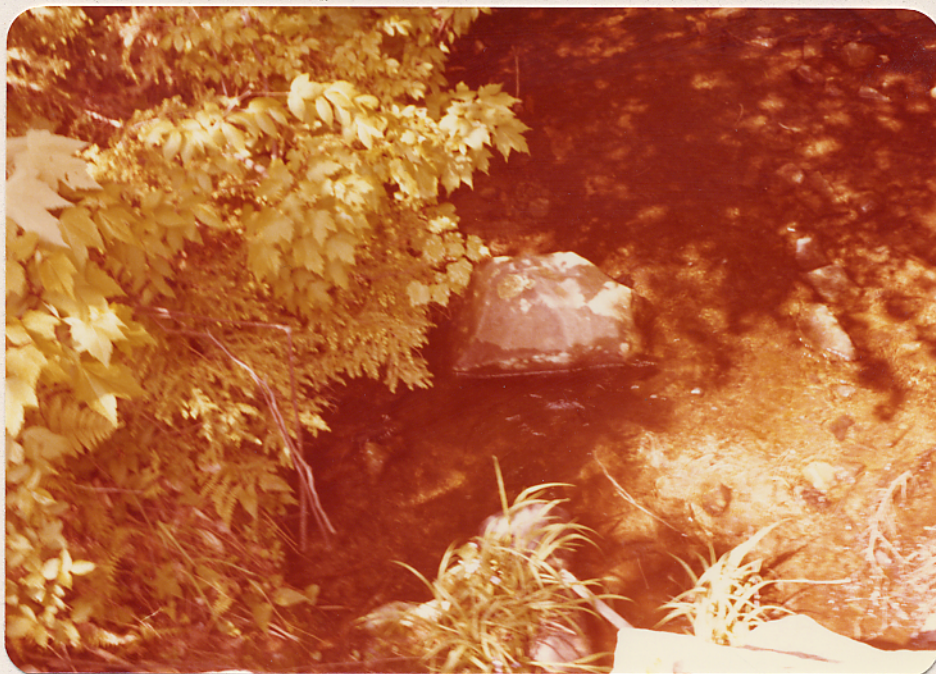
2. View of downstream channel from outlet pipe headwall

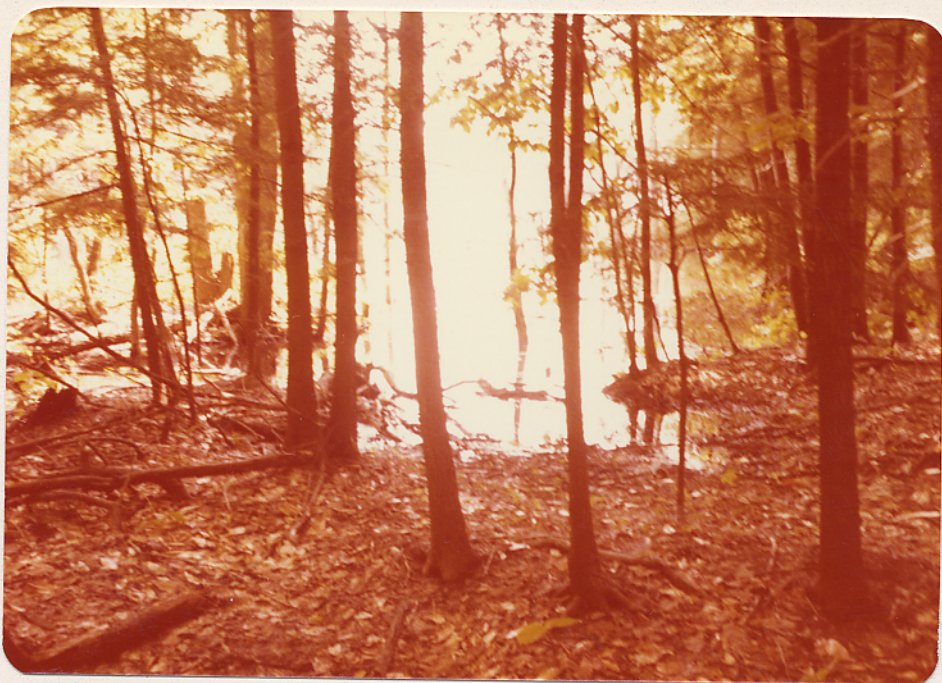
The inspection of the east shore of the pond revealed the low lying natural swale approximately one-half of the distance from the North Dam to the South Spillway, and since its high point is about 0.3 feet above the South Spillway, the swale will serve as an emergency spillway during extreme flooding conditions.

3. View of low area on east side of pond

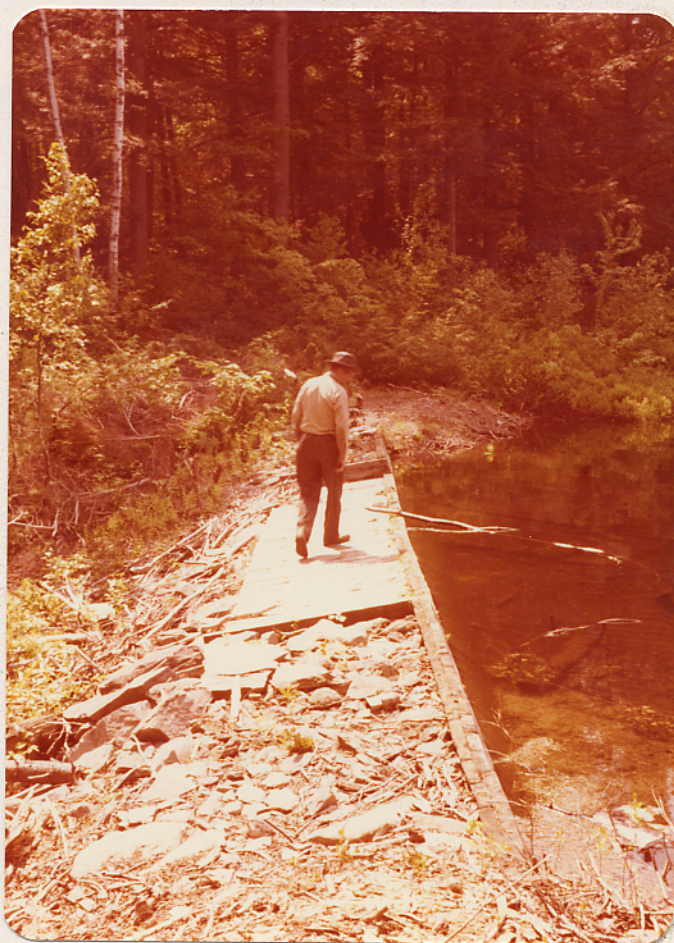
The south spillway is essentially a rock-filled crib dam with a planked upstream face and a recessed planked spillway (Appendix B, Photo 3). Despite the 22 year age of the timber, it was in FAIR condition throughout, apparently having been expertly treated with preservative salts. No seepage was evident.

4. View of South Spillway from left **abutment**

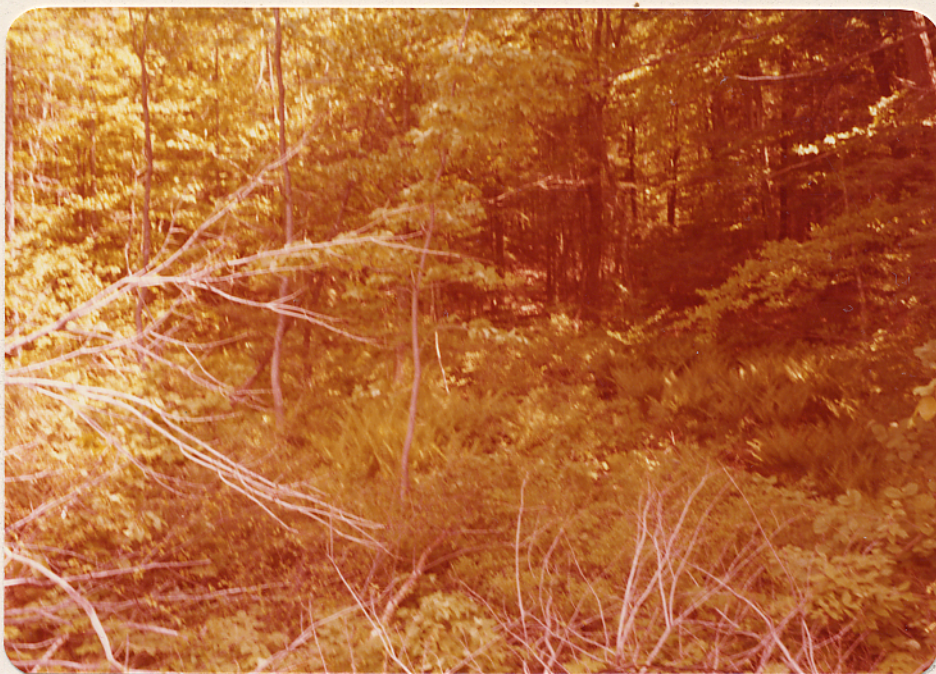
5. Channel downstream of South Spillway

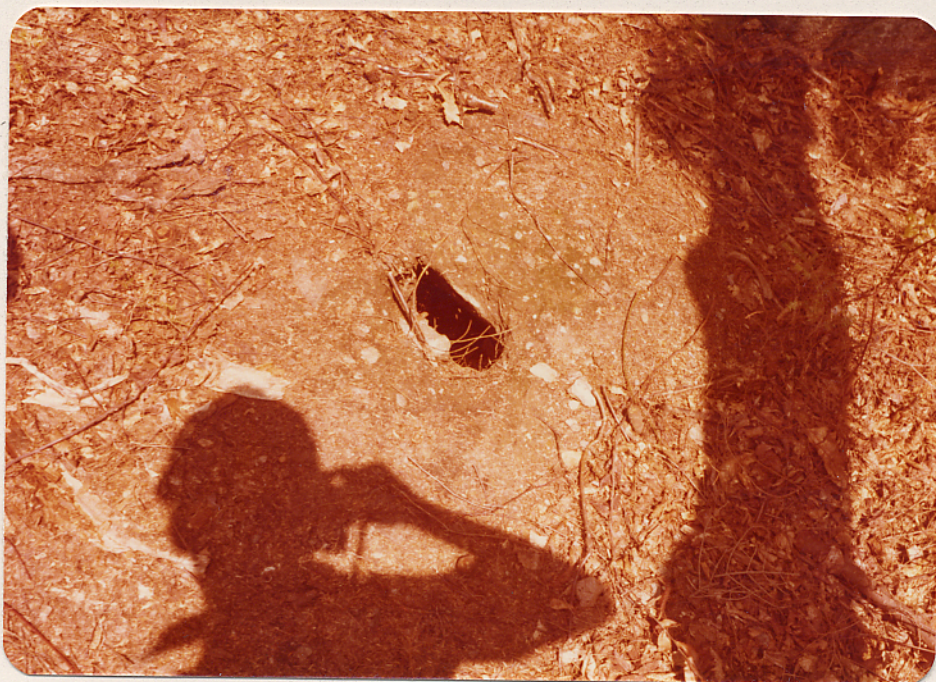
A hole, apparently caused by a burrowing rodent, is present on the left abutment of the south spillway (Photo 5), and correction is recommended herein. No structural danger attends.

6. Rodent hole near left abutment of South Spillway
